## Loss of Normal Braking

### *Final Report*

Airbus 330-343 Registration PK-LEM Flight XY5146

Prince Mohammed Bin Abdul-Aziz International Airport (OEMA)  
AL Madinah AL Munawrah, Kingdom of Saudi Arabia  
23 Dhu'l -Q 1444H – 12 June 2023G

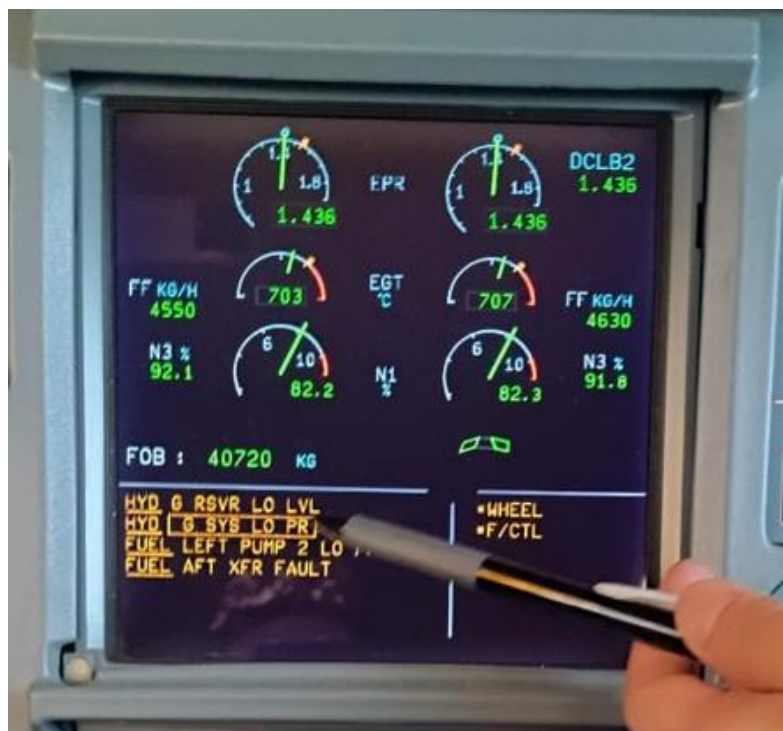
Approaching Madinah (OEMA – in clear, nighttime visual conditions), the flight crew advised Madinah Approach Control of the Green Hydraulic system failure, requesting assistance after the landing due to loss of “steering capability”. Subsequently, Madinah Approach Control declared an emergency.

Figure 1 In-flight ECAM display of Green HYD system loss.

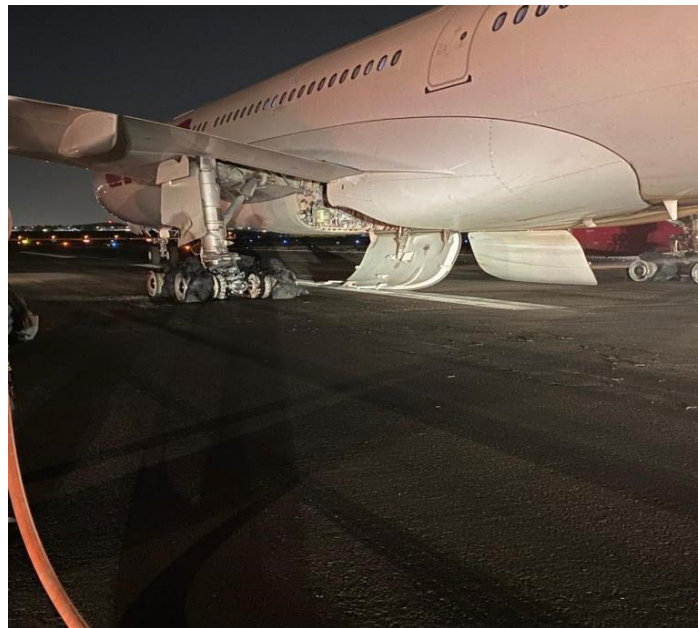
Figure 4 All Tires burst after the aircraft came to a stop.

1. All left and right main landing gear tires burst (figure 6).
2. All left and right main wheels were damaged (figure 7).
3. Both Main Landing Gear (MLG) doors have deep scratches (the result of ground contact; Figure 8).
4. BOGIE TRIMMER ACTUATOR” was leaking hydraulic, and a green actuator seal was protruding (figures 9 and 10)
5. Dented forward water drain mast (figure 11).
6. Hydraulic leaks at the left aft brakes, blue hydraulic lines (figure 12).
7. The left engine fan blade and acoustic panel (rubber debris) are damaged (figure 13).

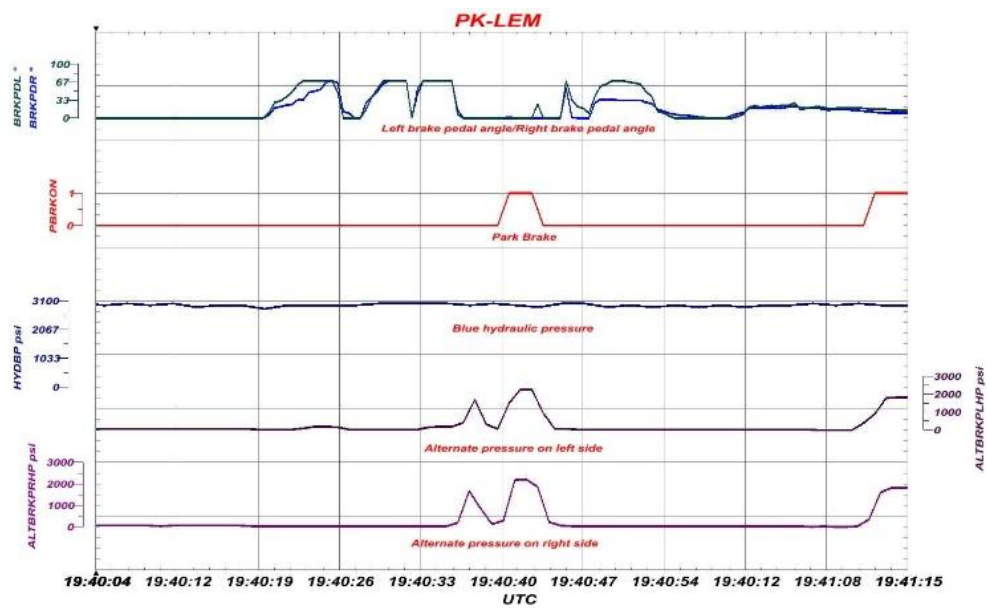
Figure 5 DFDR data: (1) as pedals were pressed, alternate pressure did not activate; (2) as the parking brake was SET, Alternate pressure activated.

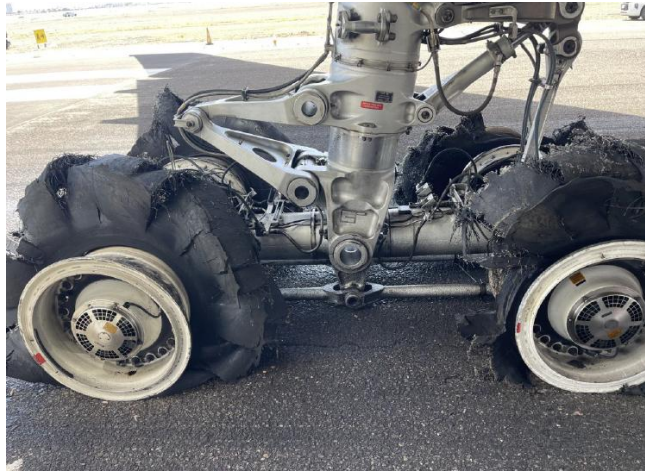
*Figure 6 Left gear tires.*

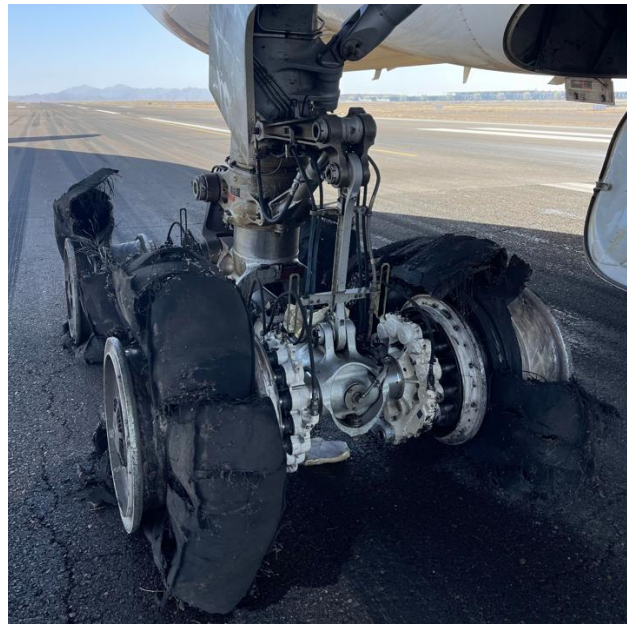
*Figure 7 Remanent of the Right gear tires.*

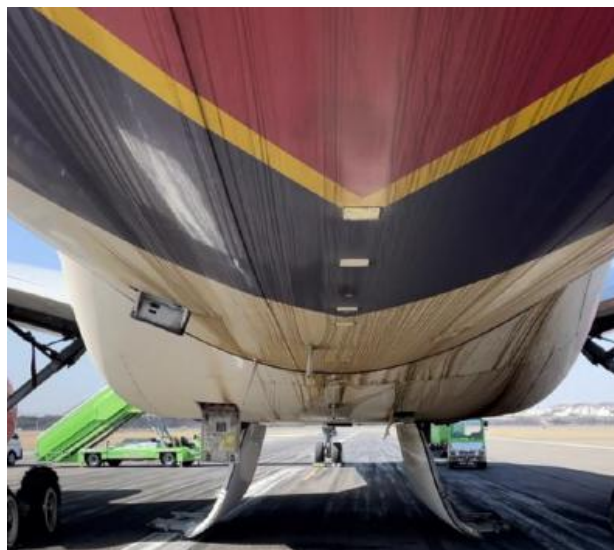
*Figure 8 Main Gear doors touching the ground, showing a hydraulic fluid stain.*

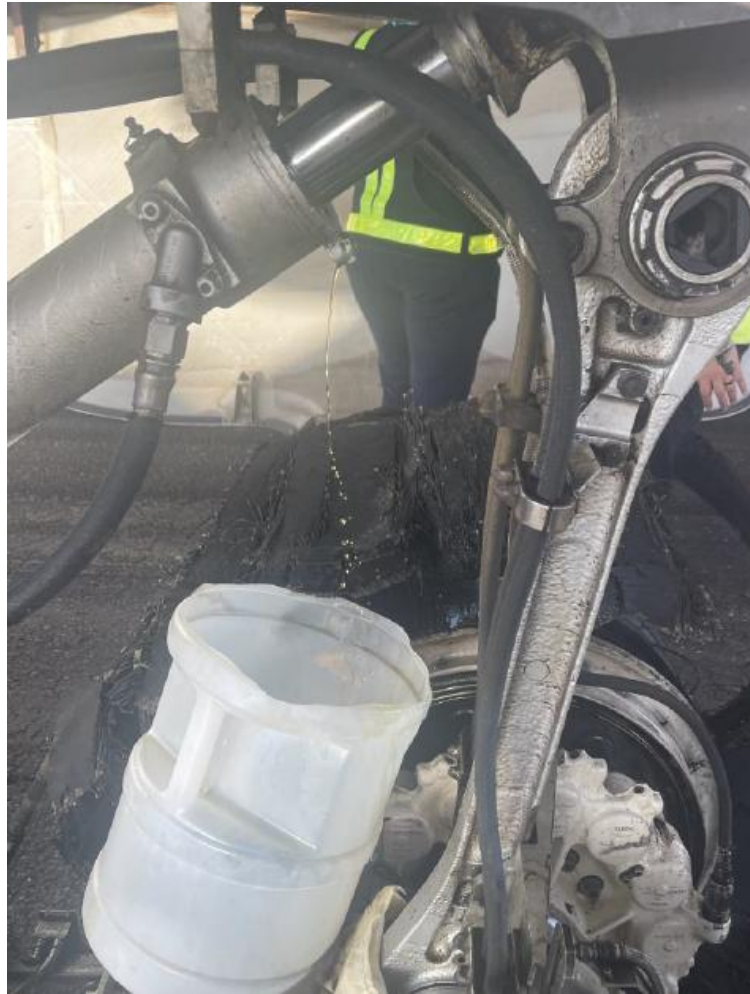
*Figure 9 The right trimmer actuator was leaking.*

Approximately 5 minutes after takeoff, the Green Hydraulic system fluid was lost because of a damaged R/H Trimmer Actuator (BOIGE TRIMMER). The actuator was disassembled at the SAFRAN facility. The component teardown revealed a crushed piston rod (Figure 27) with a damaged scraper seal (Figure 10). This caused the Green hydraulic system loss, and consequently, the NORMAL BRAKE system failed. Despite losing the Green System, the BLUE alternate braking system pressure was available.

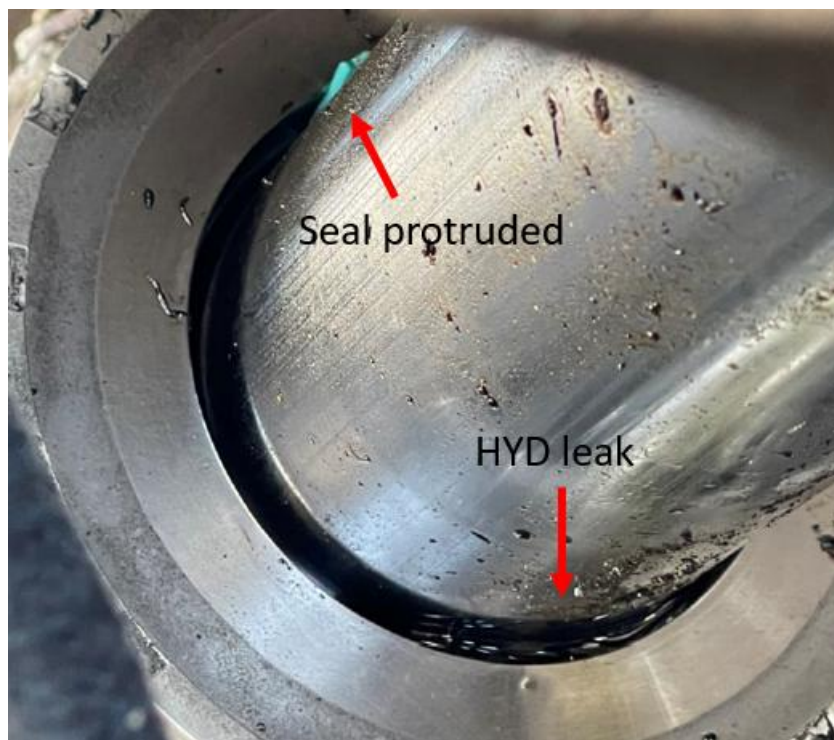
*Figure 10 Extrusion of the right-trimmer piston seal.*

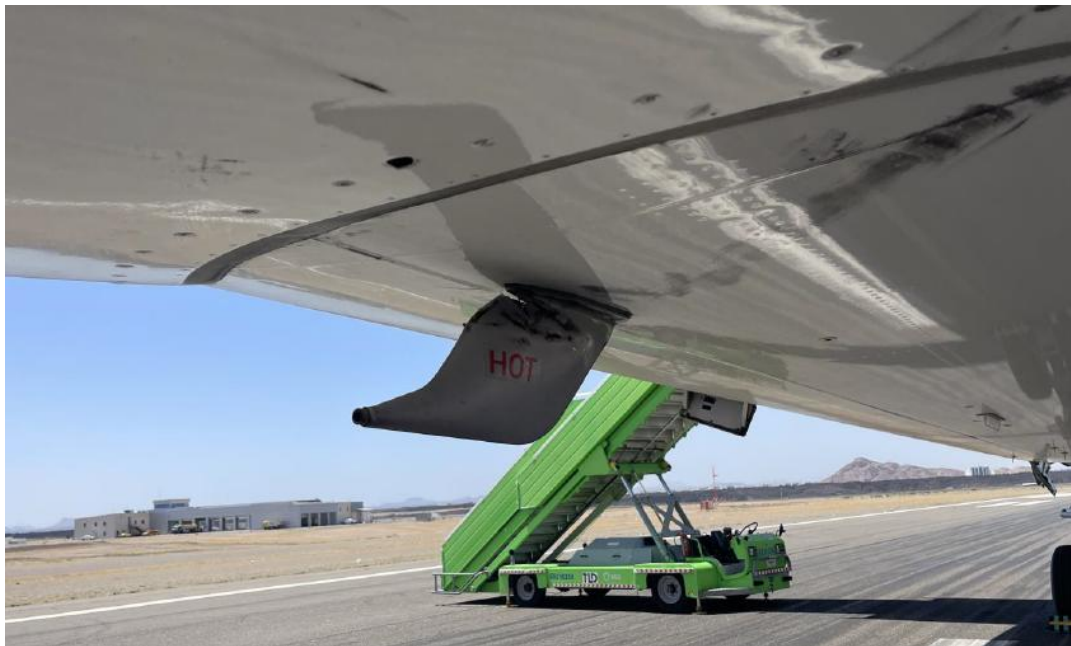
*Figure 11 Damaged FWD water drain mast.*

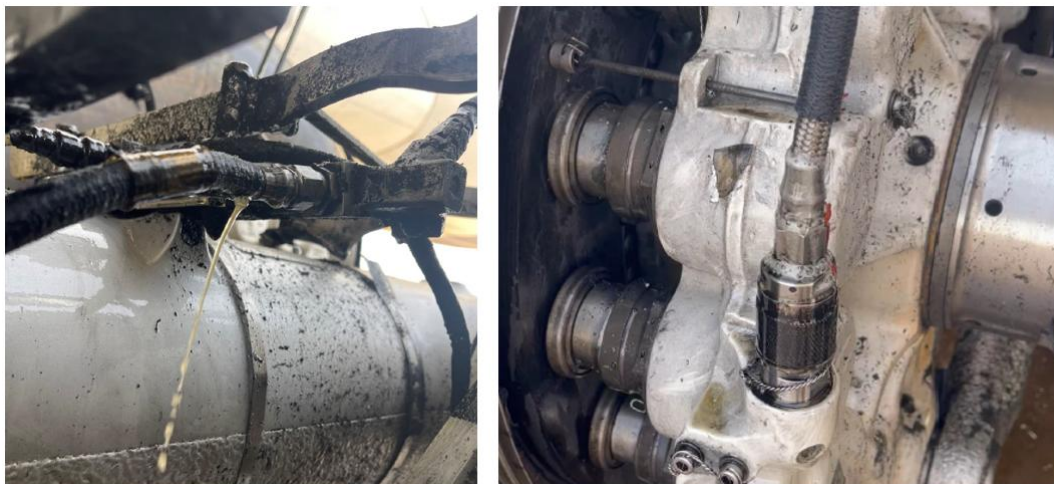
*Figure 12 Blue Hydraulic brake lines leak.*

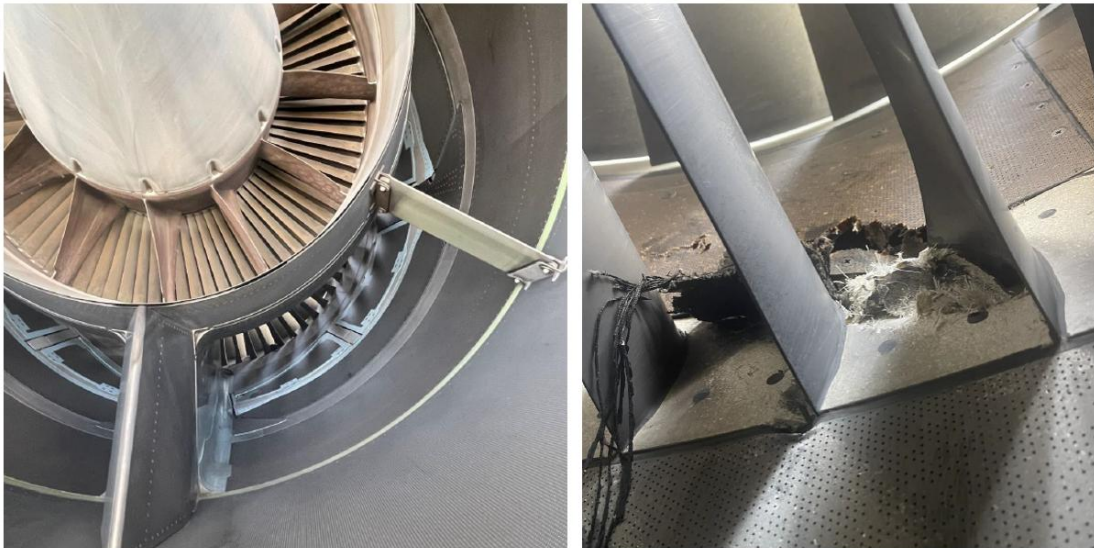
*Figure 13 L/H engine aft Fan blades acoustic panel damaged (caused by tire rubber).*

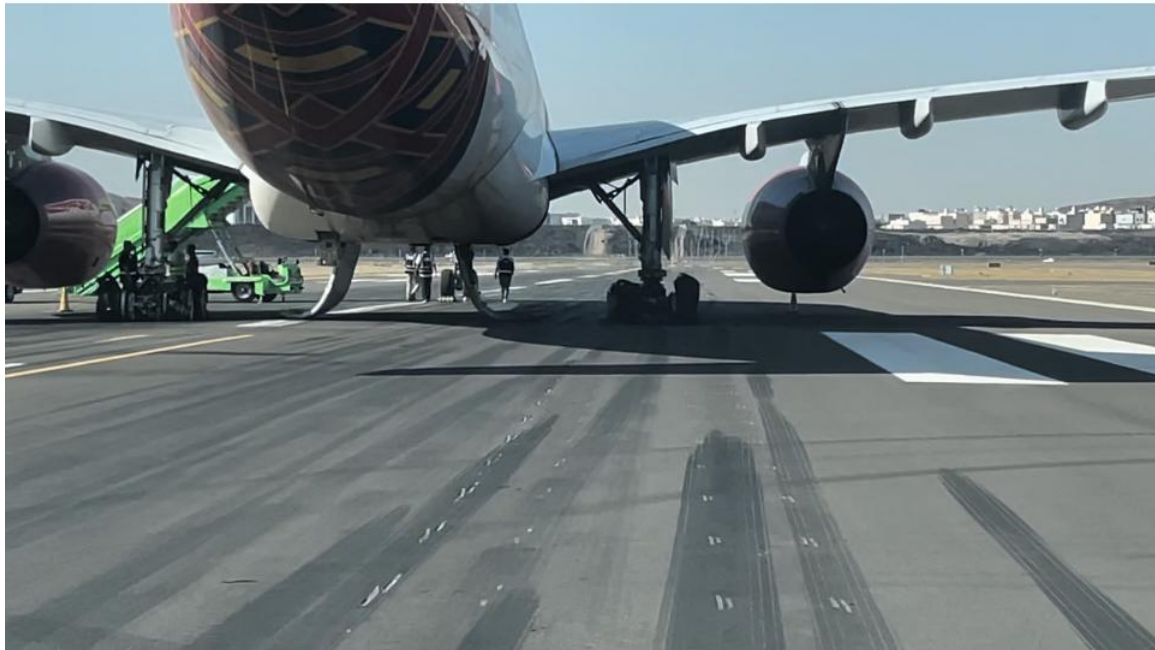
Runway 18 sweep inspection revealed surface scar damage (Figure 14).

*Figure 14 Runway 18 light surface depth “white color scar” damage.*

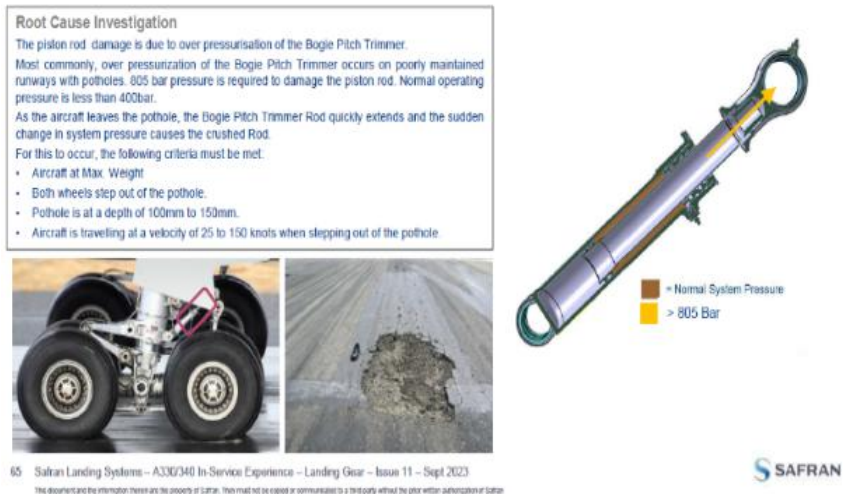
The damaged pistons have been on the manufacturer’s data, identifying the root cause as “irregular runway surface conditions” (figures 26, 28). Photos provided by other flights (on the next day) using the same runway exhibit rough runway surface areas visible to the right and left of the runway centerline. Queries to the airport operator to comment on the runway 02/20 surface condition remain unanswered. The manufacturer of the actuator, Safran, relied on In-Service Experience to identify the most common root cause for damaged Pitch Trim Actuators, as poorly maintained runway surface conditions during a one-off event, possibly on the last take-off out of Comoros. Note: Technical log records show the aircraft operated 4 flights to and from Comoros Aerodrome.

Figure 26 Extract out of Safran Inservice Experience report

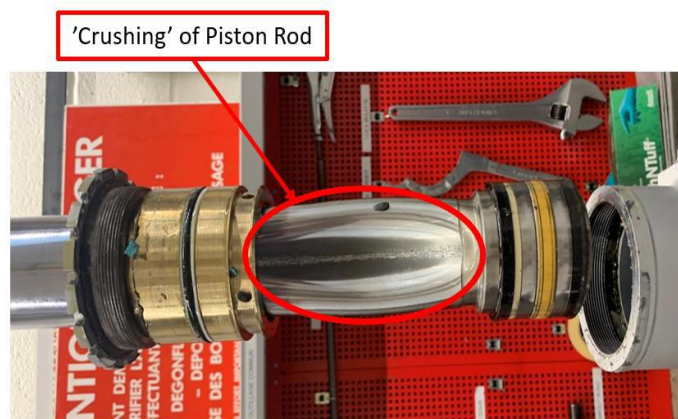
Figure 27 Pitch Trimmer Internal Piston damage

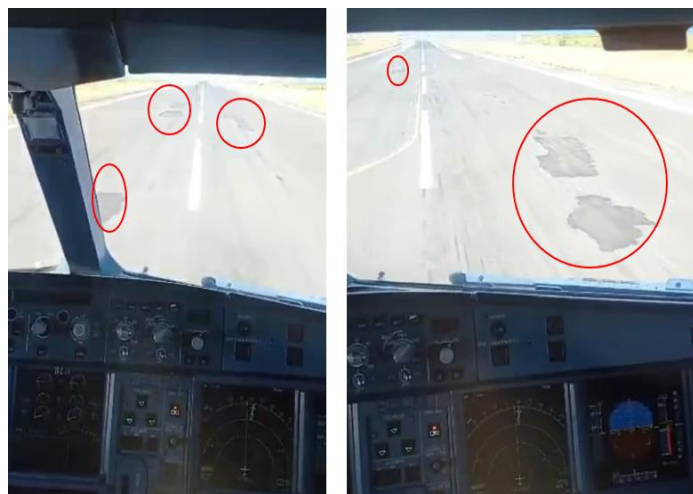
Figure 28 Photo showing the condition Comoros runway on the day following the event

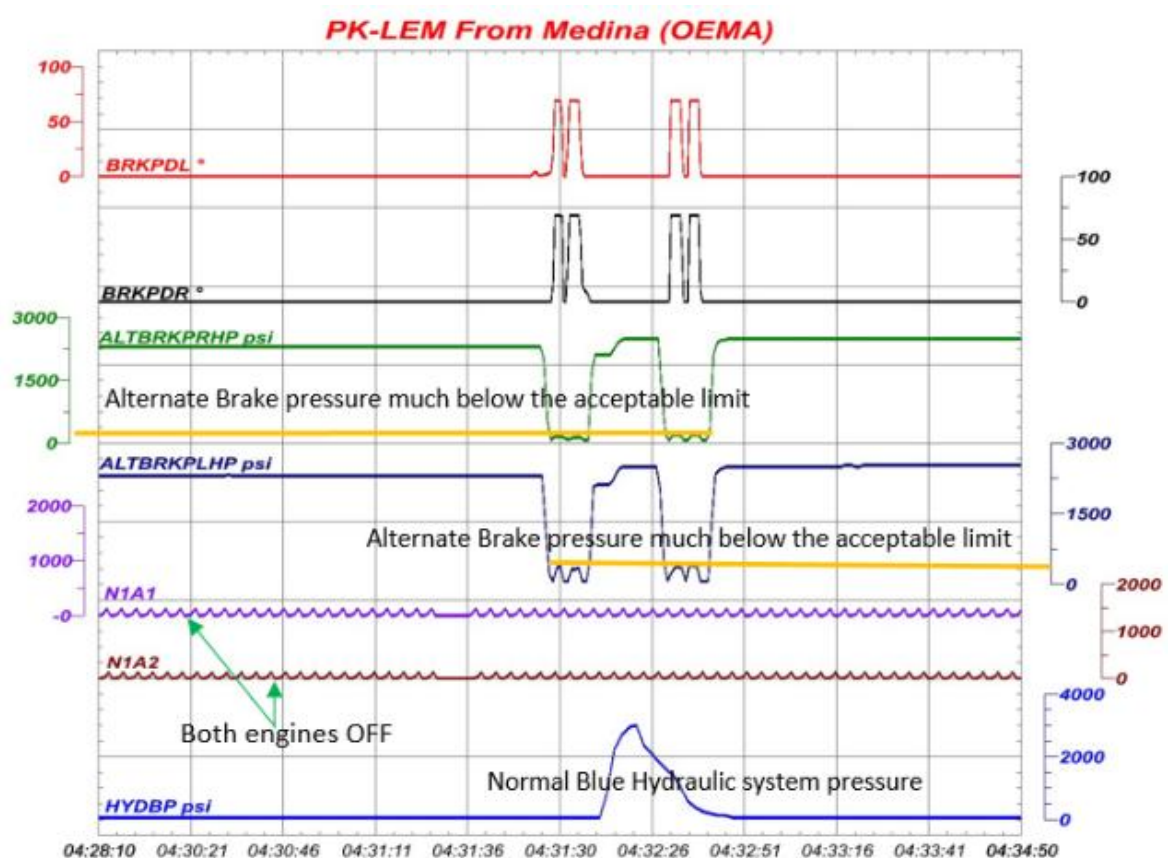
The flight crew stated that they performed the First Flight of the Day Alternate Brake checking action; however, the DFDR shows unacceptable brake pressure indications of less than 416 PSI on both alternate pressures as opposed to between 2400 psi and 2700 psi (Figure 29). Below pressure limits, when shown on the Triple Gauge Indicator, indicate NO ALTERNATE BRAKE AVAILABILITY.

*Figure 25 DFDR FC first flight check (12 Jun 2024) of the Alternate Brake shows the test was unsuccessful.*
