## Loss of Normal Braking

### *Final Report*

Airbus 330-343 Registration PK-LEM Flight XY5146

Prince Mohammed Bin Abdul-Aziz International Airport (OEMA)  
AL Madinah AL Munawrah, Kingdom of Saudi Arabia  
23 Dhu'l -Q 1444H – 12 June 2023G

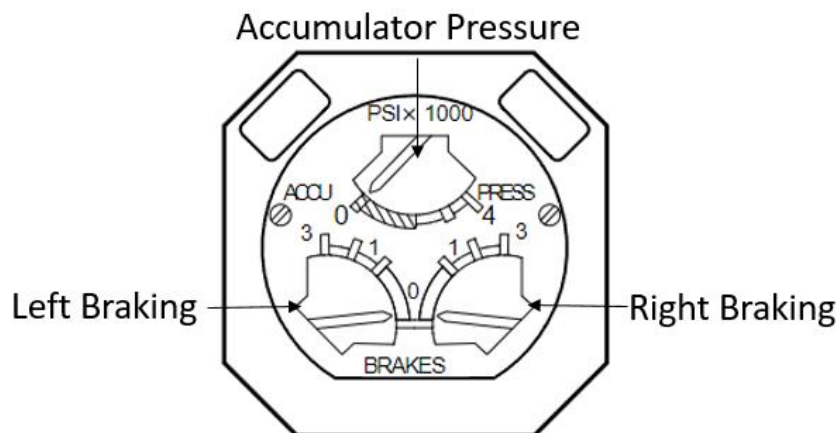
Figure 16 Triple Pressure Indicator

The *triple* pressure indicator (Figure 16) has three dials on its front face showing the brakes and accumulator pressures. When the Green system is not operating, and the blue system is active while pressing on the pedals, the Left and Right braking needles should move between 2400 and 2700 psi.

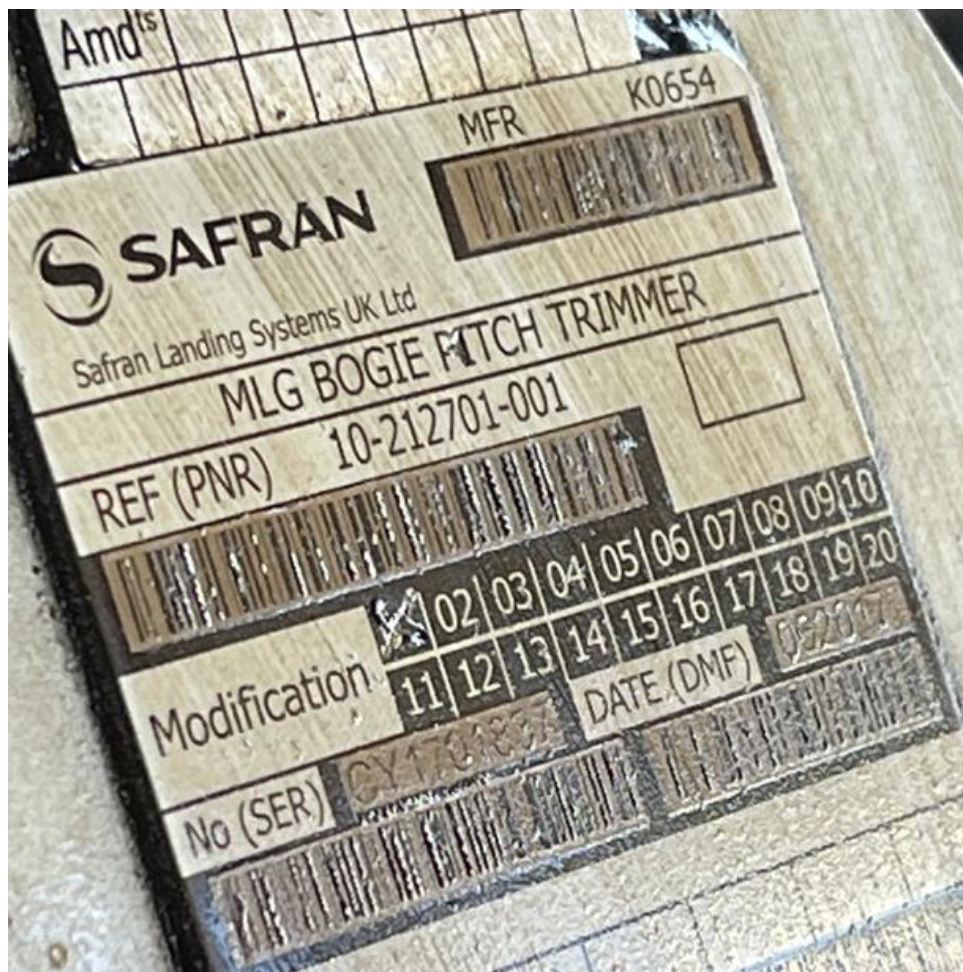
*Figure 24 R/H Trimmer Actuator data plate*

Safran provided a full, detailed investigation report showing the root cause of the trimmer actuator failure, which will be explained in the analysis part of this report. Also, the Safran report shows the timeline of the lifecycles of the actuator ( 3460 FC / 12980 FH). The R/H MLG Movement Traceability Sheet (MTS) provided by the operator stated that the affected Bogie Pitch Trimmer had not been subject to any in-service removals during its operational life. The affected Bogie Pitch Trimmer P/N 10-212701-001 has been subjected to design improvement of corrosion resistance according to the recommended Service Bulletin (SB) A33/34-32-318 (Figure 24). In addition, SAFRAN expertise indicated that a modification to increase Bogie Pitch Trimmer robustness has been developed, as detailed in Service Bulletin (SB) A33/34-32-318 (Figure 24). This modification introduces a change to the flow control device, reducing the damping of the Bogie Pitch Trimmer to lower the build-up of internal pressure in the unit. This SB was not implemented on the PK-LEM Trimmer actuator, as indicated in the Actuator data plate (Figure 25).

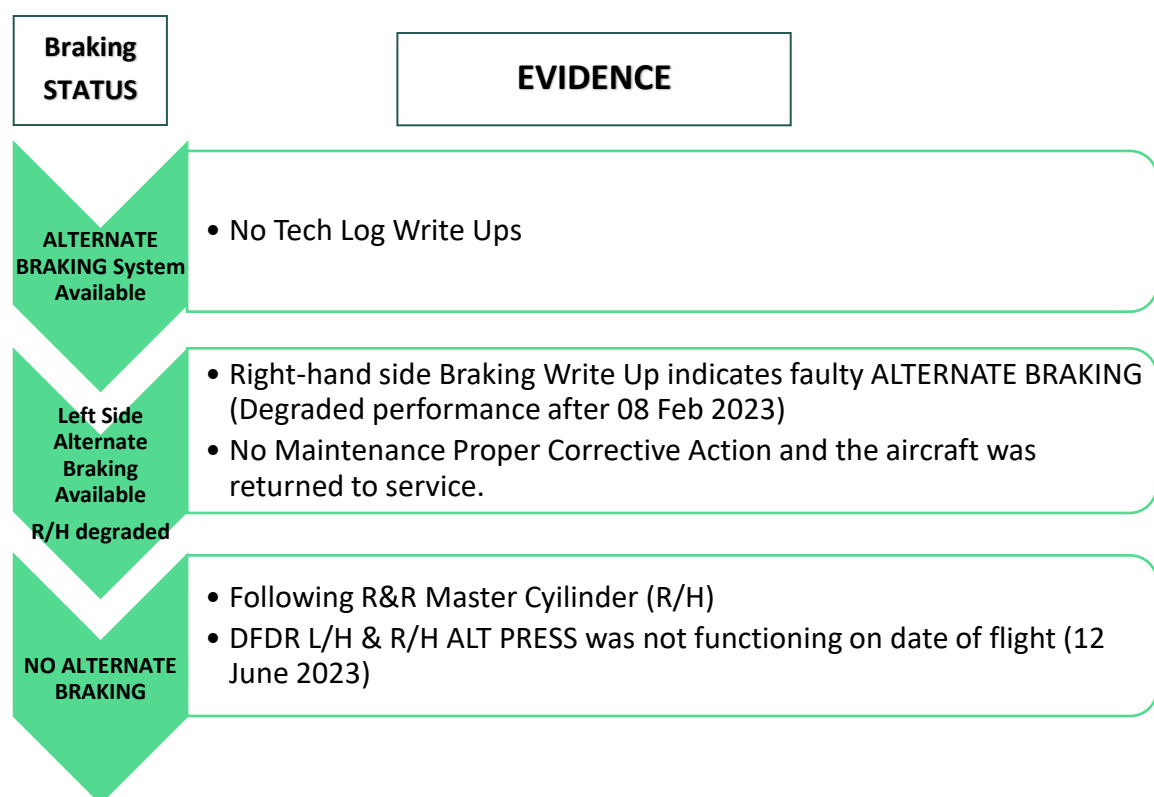
*Figure 29 Logical downgrade of the alternate brake*

The flight crew stated that they performed the First Flight of the Day Alternate Brake checking action; however, the DFDR shows unacceptable brake pressure indications of less than 416 PSI on both alternate pressures as opposed to between 2400 psi and 2700 psi (Figure 29). Below pressure limits, when shown on the Triple Gauge Indicator, indicate NO ALTERNATE BRAKE AVAILABILITY.

Provided the GREEN SYSTEM is normal, the flight crew will not notice or become aware of the abnormal Alternate BRAKING System status if they misinterpret the triple indicator or overlook it. Below, Figure 28 describes the logical downgrade of the Alternate Brake System status based on Technical Log write-ups and DFDR data.

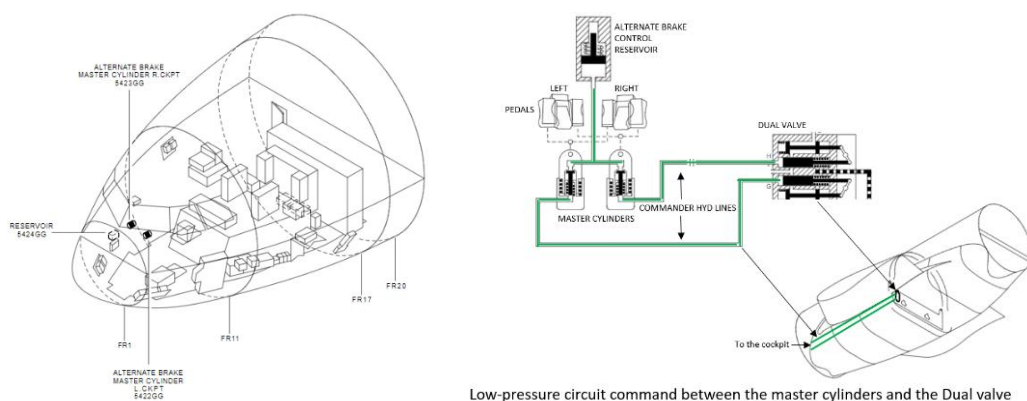
On 12, 06, 2023, the date of the event, while doing the first flight check of the alternate Braking system as required by the FCOM, the DFDR indicated that when the FDC pressed on the R/H pedal, the reading was 196 psi, significantly below the expected range of 2400 psi to 2686 psi. When pressing the left-hand (L/H) pedals, the pressure read 400 psi, falling outside the expected range. Since there was no complaint about the L/H pedal, this suggests a potential error in the removal and installation process of the R/H master cylinder might disturbed the low-pressure command lines. Additionally, the procedures for removing and installing the R/H master cylinder require testing the alternate braking pressure on both the left and right sides to ensure that the Triple Indicator shows a reading between 2400 psi and 2682 psi. However, DFDR data indicate that this test was either not conducted or was performed incorrectly. The loss of alternate braking is the failure to properly bleed the low-pressure command lines during the maintenance work on the R/H master cylinder replacement.

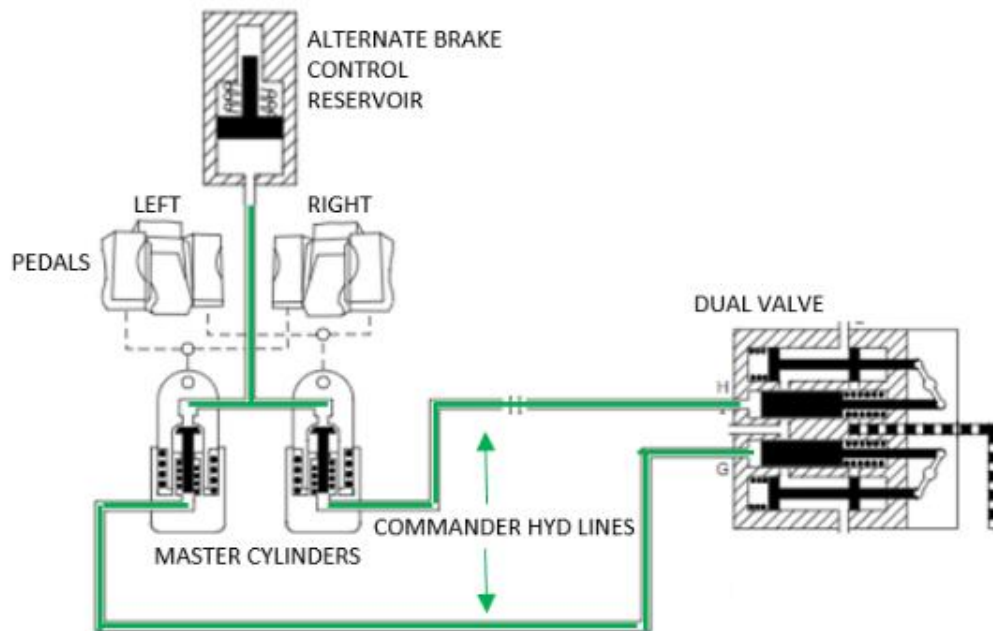
Low-pressure circuit between the Master cylinder and the Dual valve

All previous faults reported by the Flight Crew consistently identified issues with the right-hand (R/H) pedals, including faulty readings and a spongy feeling. Fault No. 5 was the last fault reported issue after a series of complaints about the R/H pedals. On 26 May 2023, the maintenance crew discovered that the R/H master cylinder was leaking hydraulic fluid. A leak in the master cylinder causes a spongy feeling and affects the low-pressure circuit in the alternate braking system, leading to the triple indicator reading

below the acceptable range. This explains the complaints related to the previous four faults reported by the FC. However, it appears that the maintenance intervention during the removal and replacement process affected the low-pressure commanded circuit, resulting in the loss of the alternate braking system. The hydraulic leak from the master cylinder is likely the root cause of the four reported defects, while improper maintenance actions or potential error processes during the removal and replacement of the R/H master cylinder are likely the cause of the loss of the alternate braking system (left and right), leading to the event.
